Greater Dublin Drainage

Alternative Sites Assessment - Phase Two Sites Assessment and Route Selection Report

Cultural Heritage

May 2012

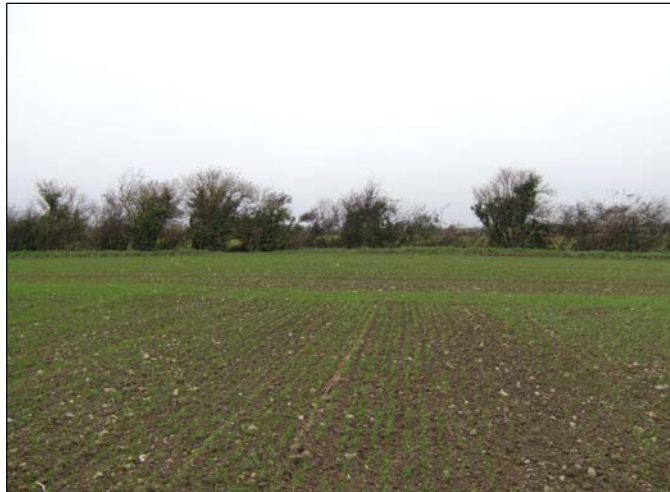
Plate 6.1 – Site of CH 38 (probable ring ditch), facing west

CH 38, 39, 40 and 41 were inspected in order to discern whether there were any upstanding remains and the topographic location of the sites. No upstanding remains were identified at CH 38, which is under arable crop. However, the site of the possible ring ditch occupied an area of higher ground (Plate 6.1), which overlooks the lower ground to the north. This area is characterised by the flood plain associated with the River Broadmeadow. It is not unusual to find prehistoric burial features, such as ring ditches in close proximity to water courses.

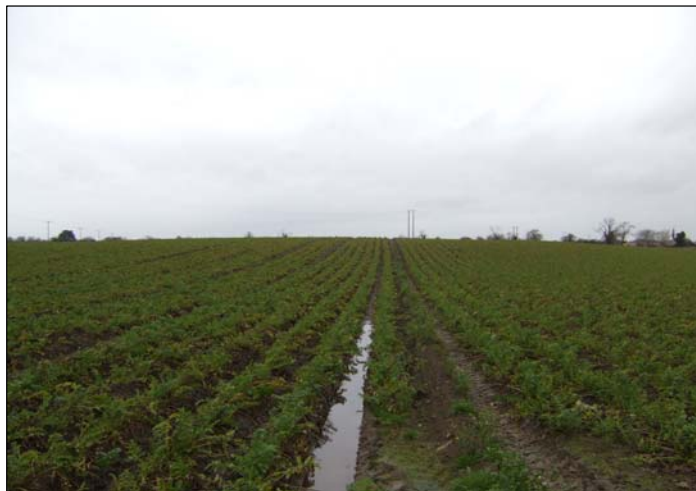
Plate 6.2 – Site of CH 39 (possible ringfort) on high ground, facing WNW

Both the sites of CH 39 and CH 40 were found to occupy a ridge of higher ground, which again overlooks the River Broadmeadow to the north (Plate 6.2, 6.3). Both the sites are linked by this ridge and may be contemporary. Whilst no above ground features could be identified, the location of these features on a ridge makes it likely that they are indeed early medieval settlement sites. Prior to post medieval drainage improvements in the area it is likely that the landscape to the north was characterised by marshy ground, meaning that both CH 39 and 40 would have been safe from flooding but close to the water course for travelling; close to a renewable food source and within 1km of the major early medieval settlement at CH 47. In addition, the early medieval field system, which is located c. 160m to the north-west, also occupies higher ground.

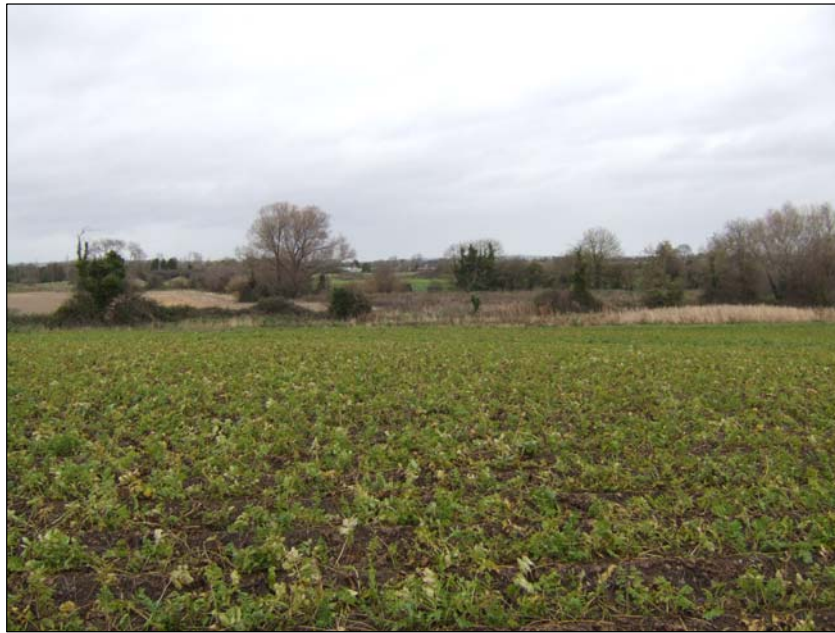
Plate 6.3 – A view NNE from the site of CH 40 (possible ringfort), over River Broadmeadow flood plain

No upstanding remains were noted at the site of CH 41, but the probable ring ditch occupies the same undulating ridge as CH 40 and 39. It appears that all that remains at the four sites of potential consist of sub-surface ditches, which appear within the arable crop as marks when the conditions are correct. Any associated banks that may have existed have been removed by intensive arable production in the area.

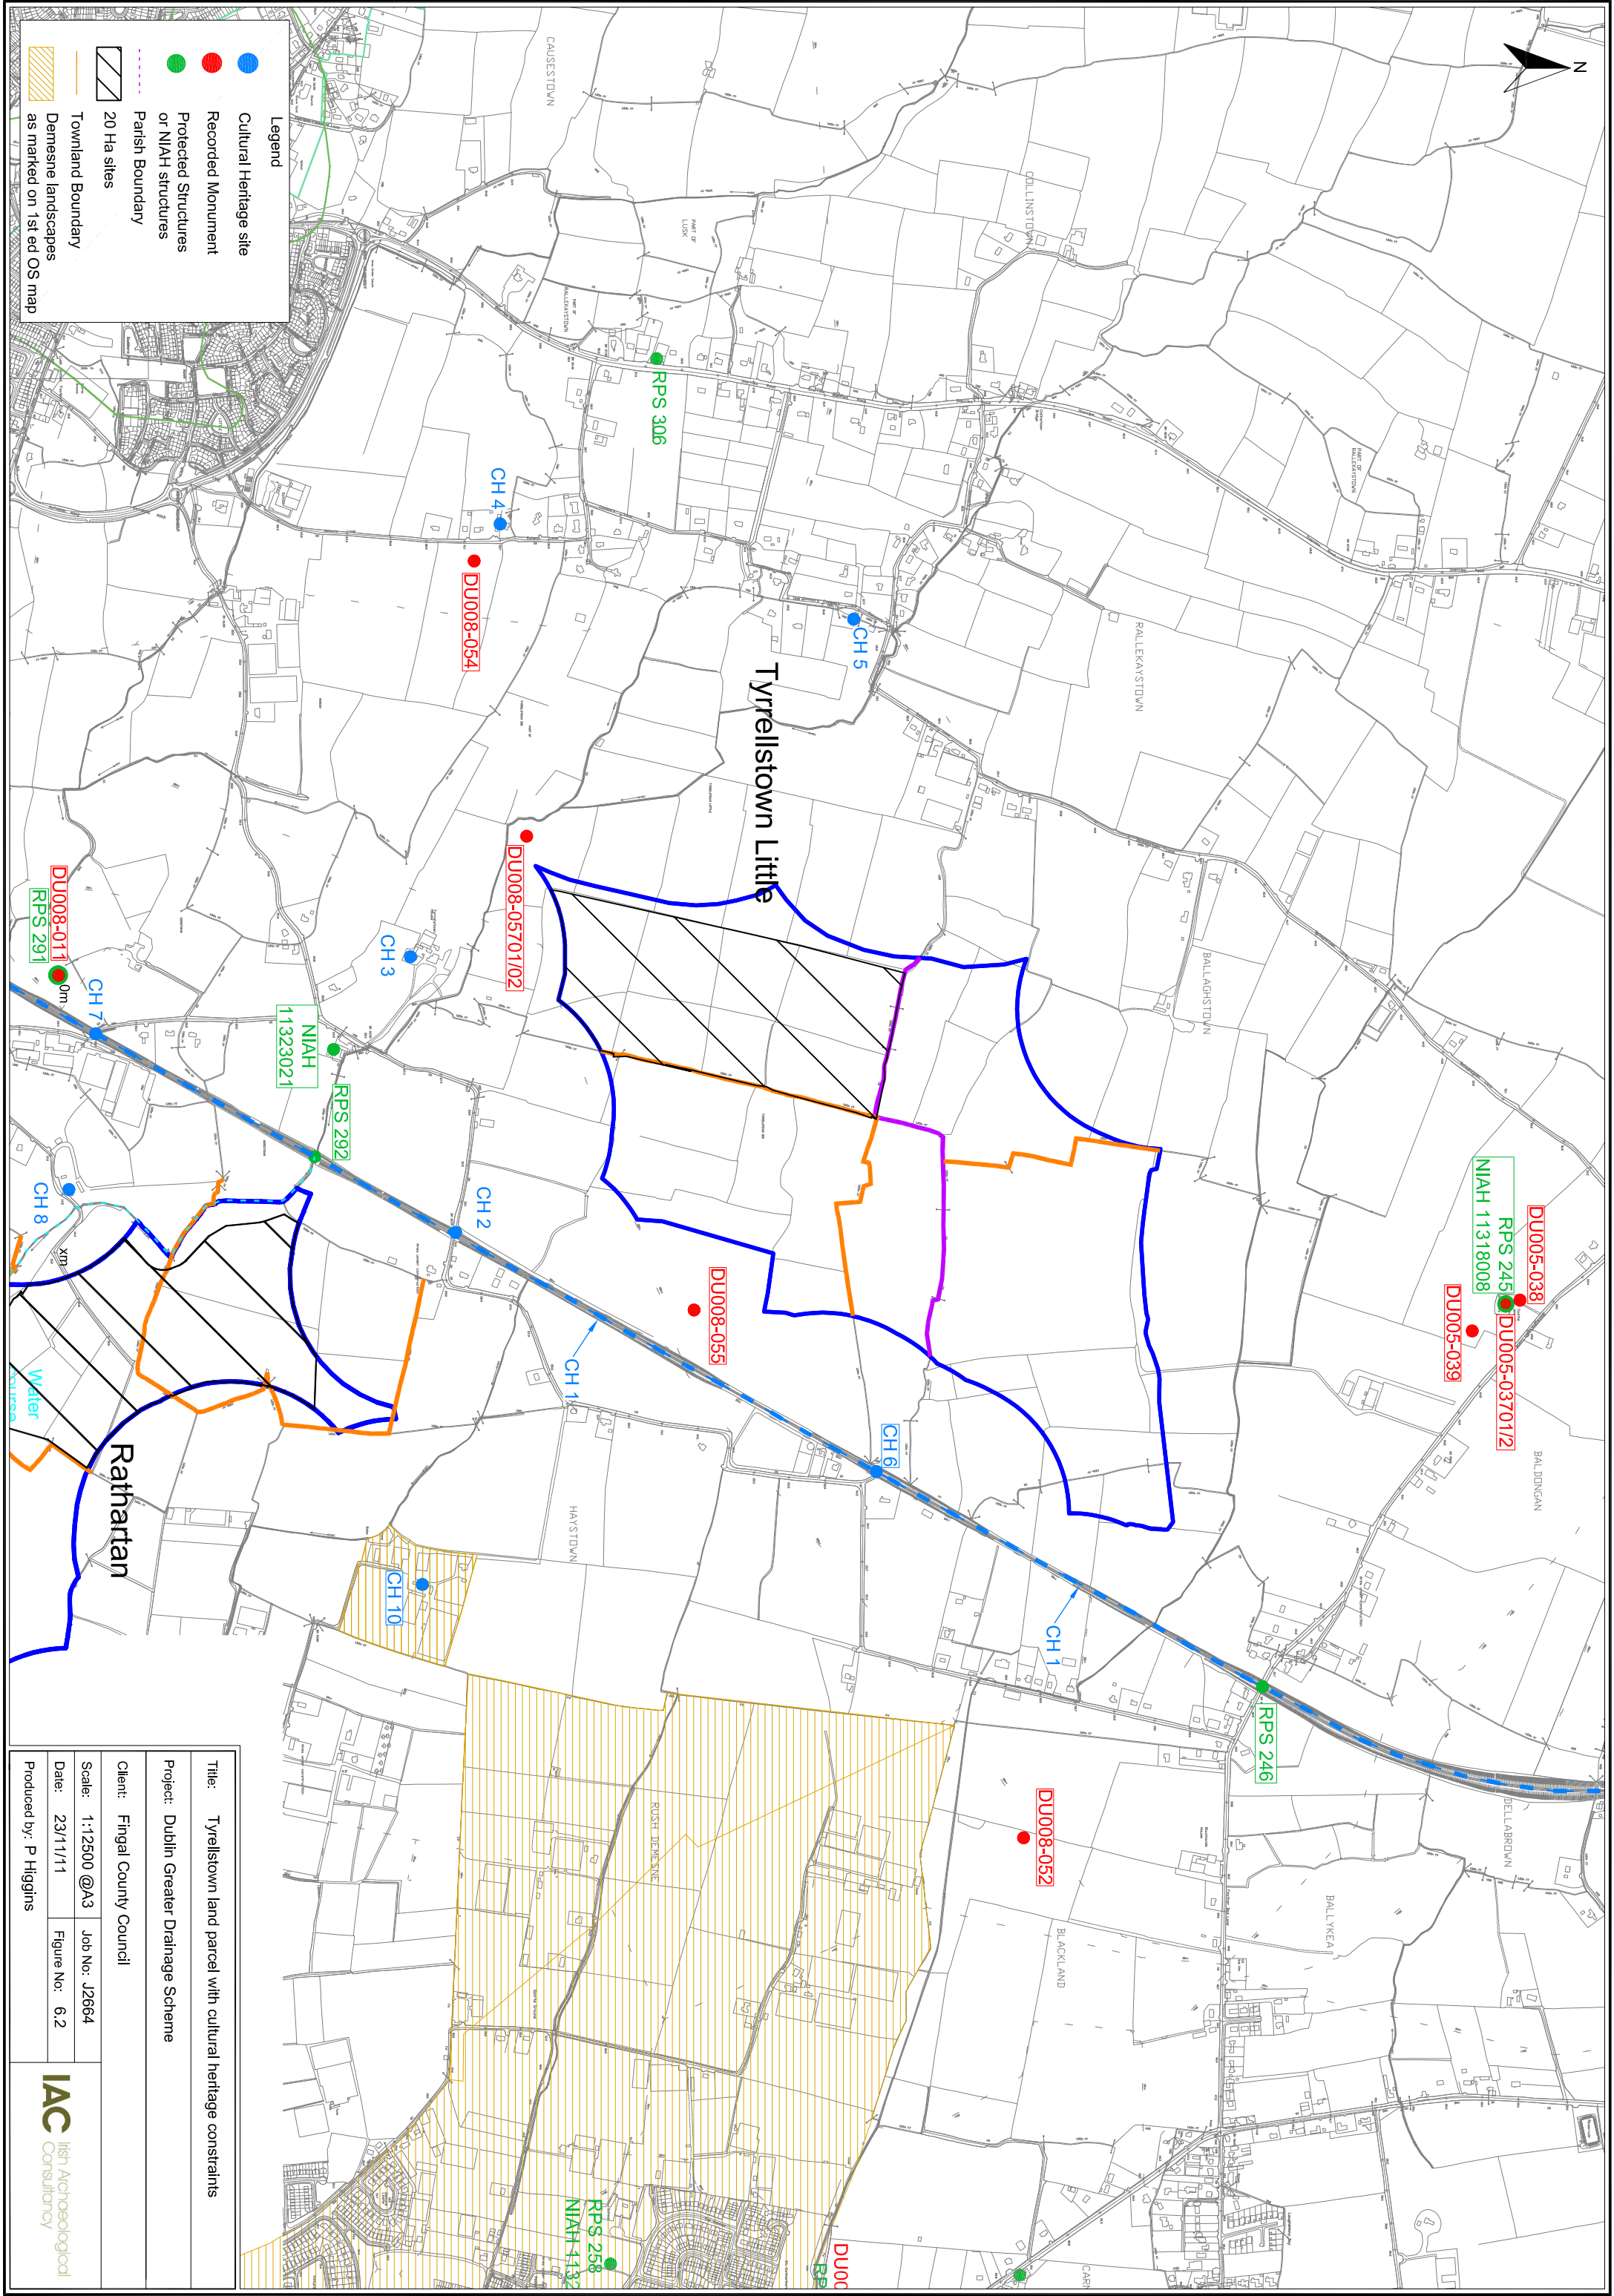
Title: Tyrellstown land parcel with cultural heritage constraints		
Project: Dublin Greater Drainage Scheme		
Client: Fingal County Council		
Scale: 1:12500 @A3	Job No: J2664	
Date: 23/1/11	Figure No: 6.2	
Produced by: P Higgins

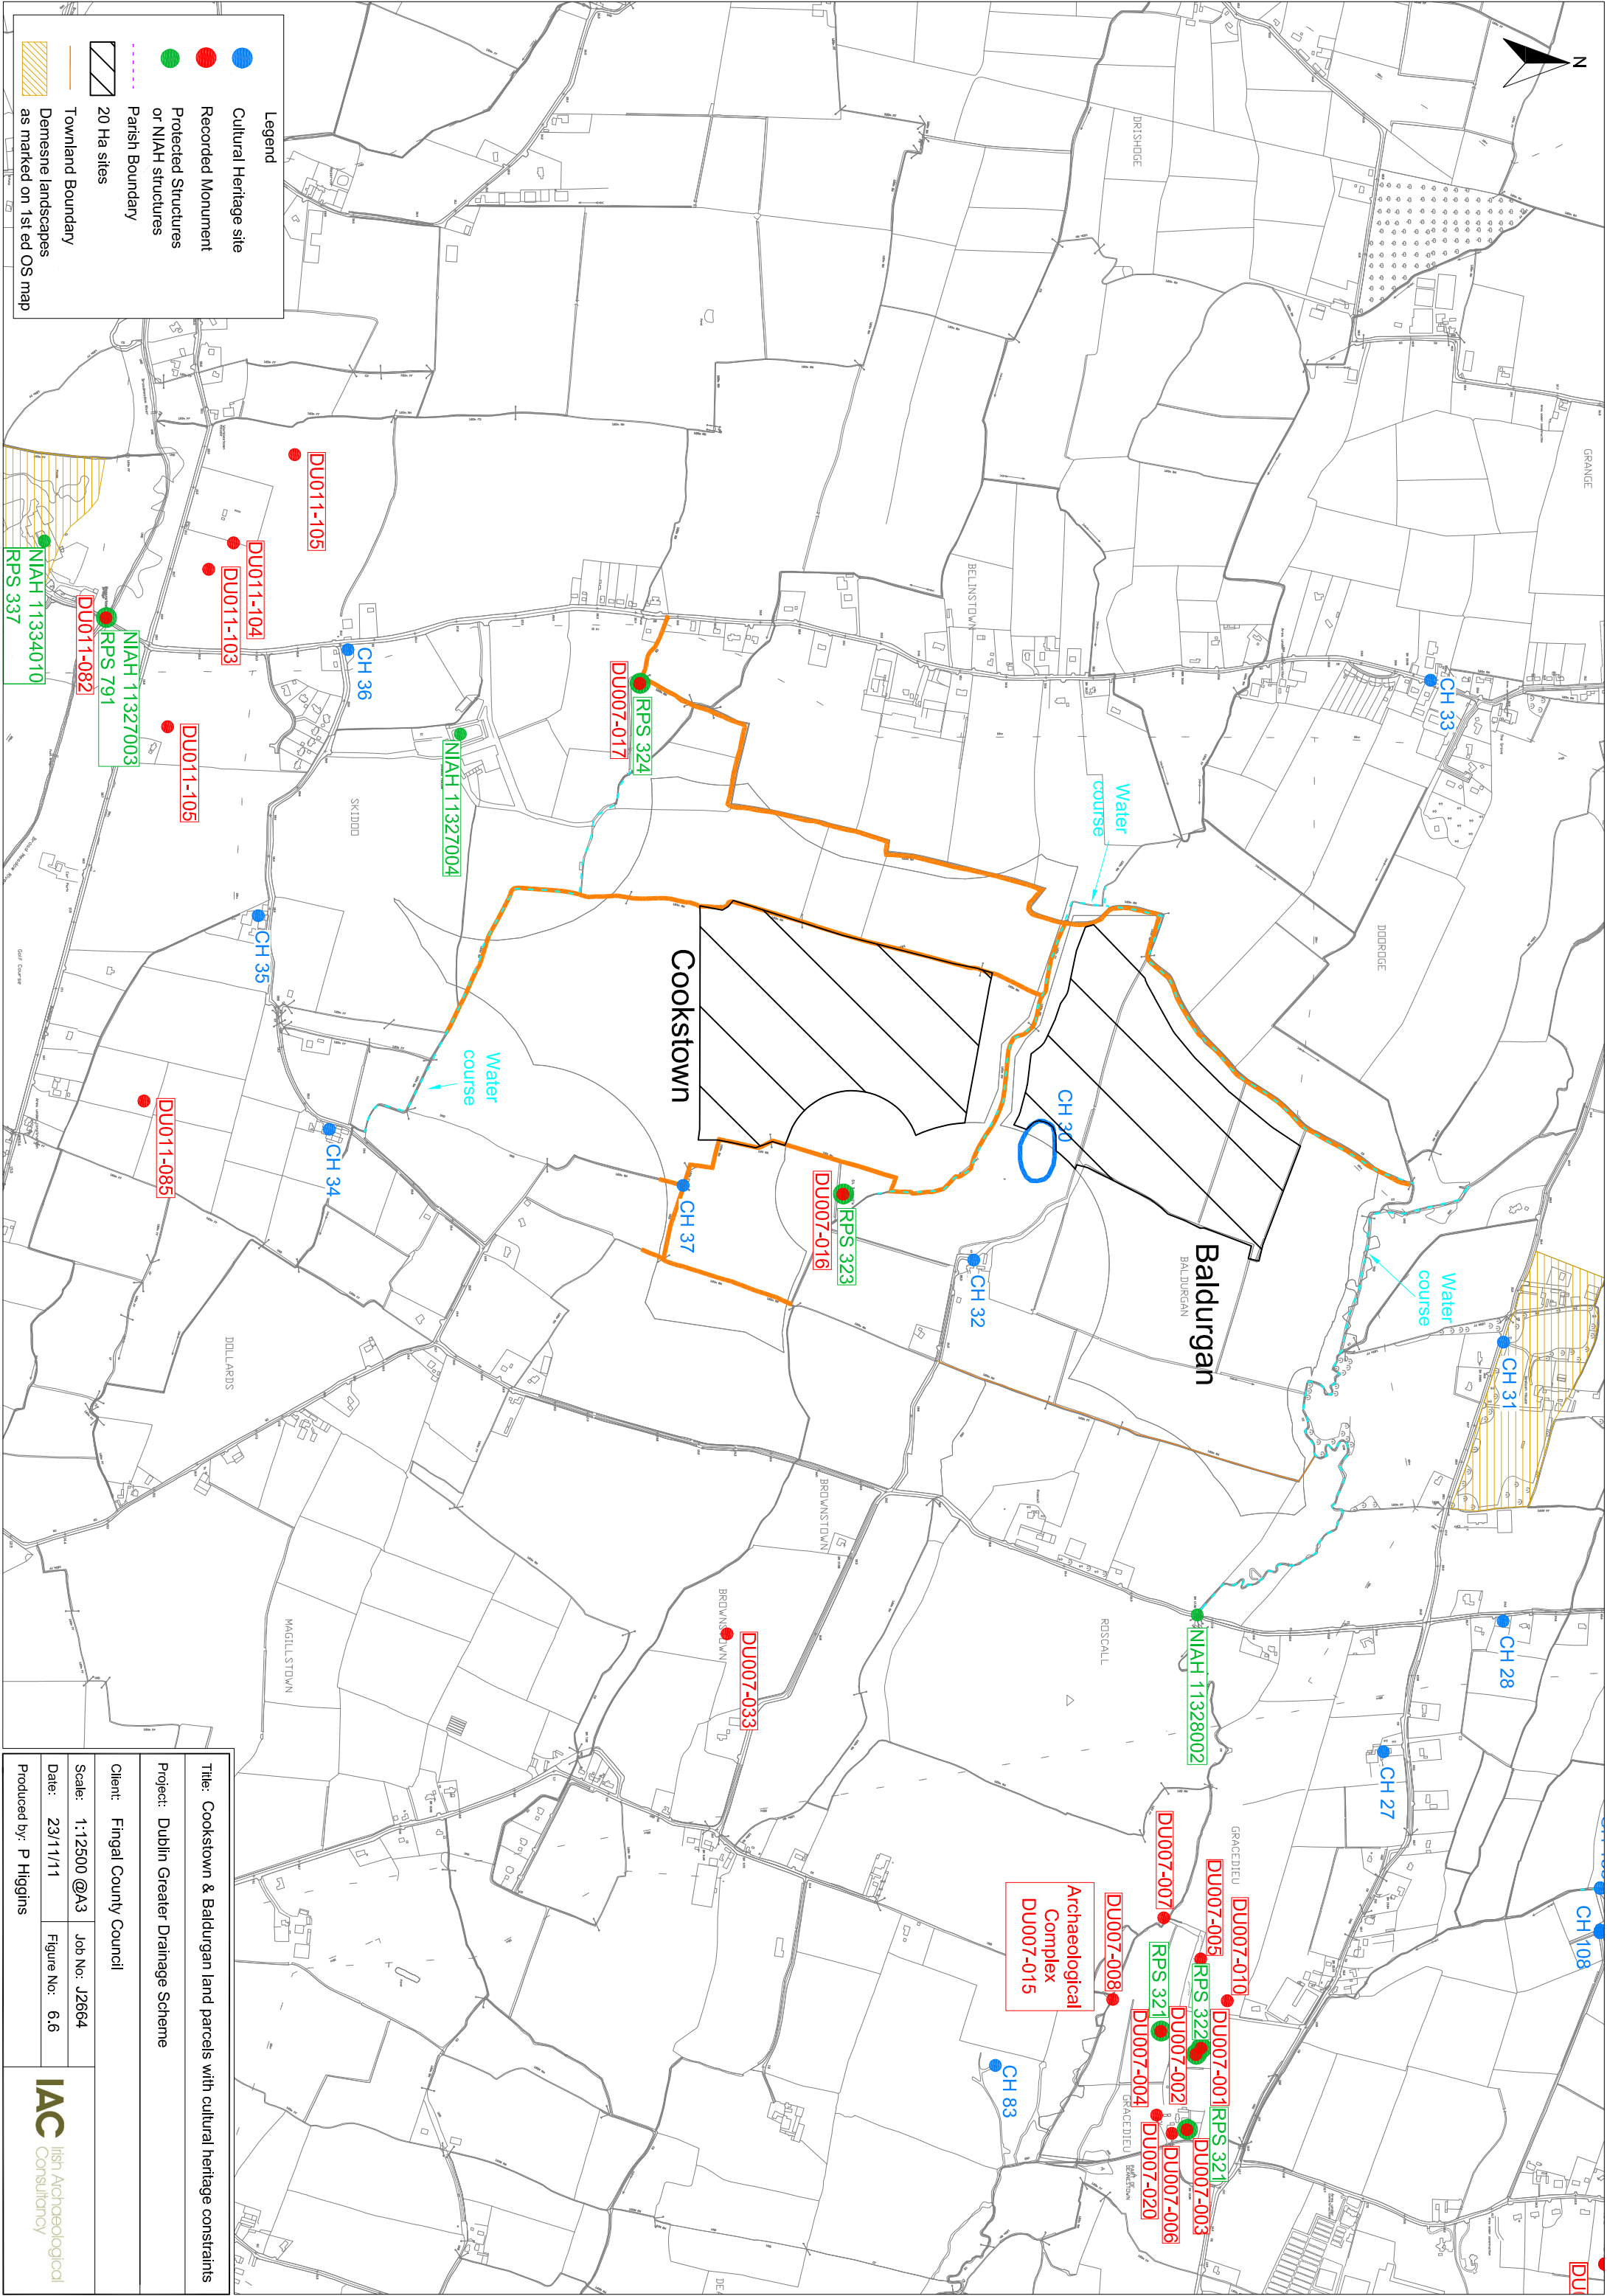
Title: Cookstown & Baldurgan land parcels with cultural heritage constraints		
Project: Dublin Greater Drainage Scheme		
Client: Fingal County Council		
Scale: 1:12500 @A3	Job No: J2664	
Date: 23/11/11	Figure No: 6.6	
Produced by: P Higgins

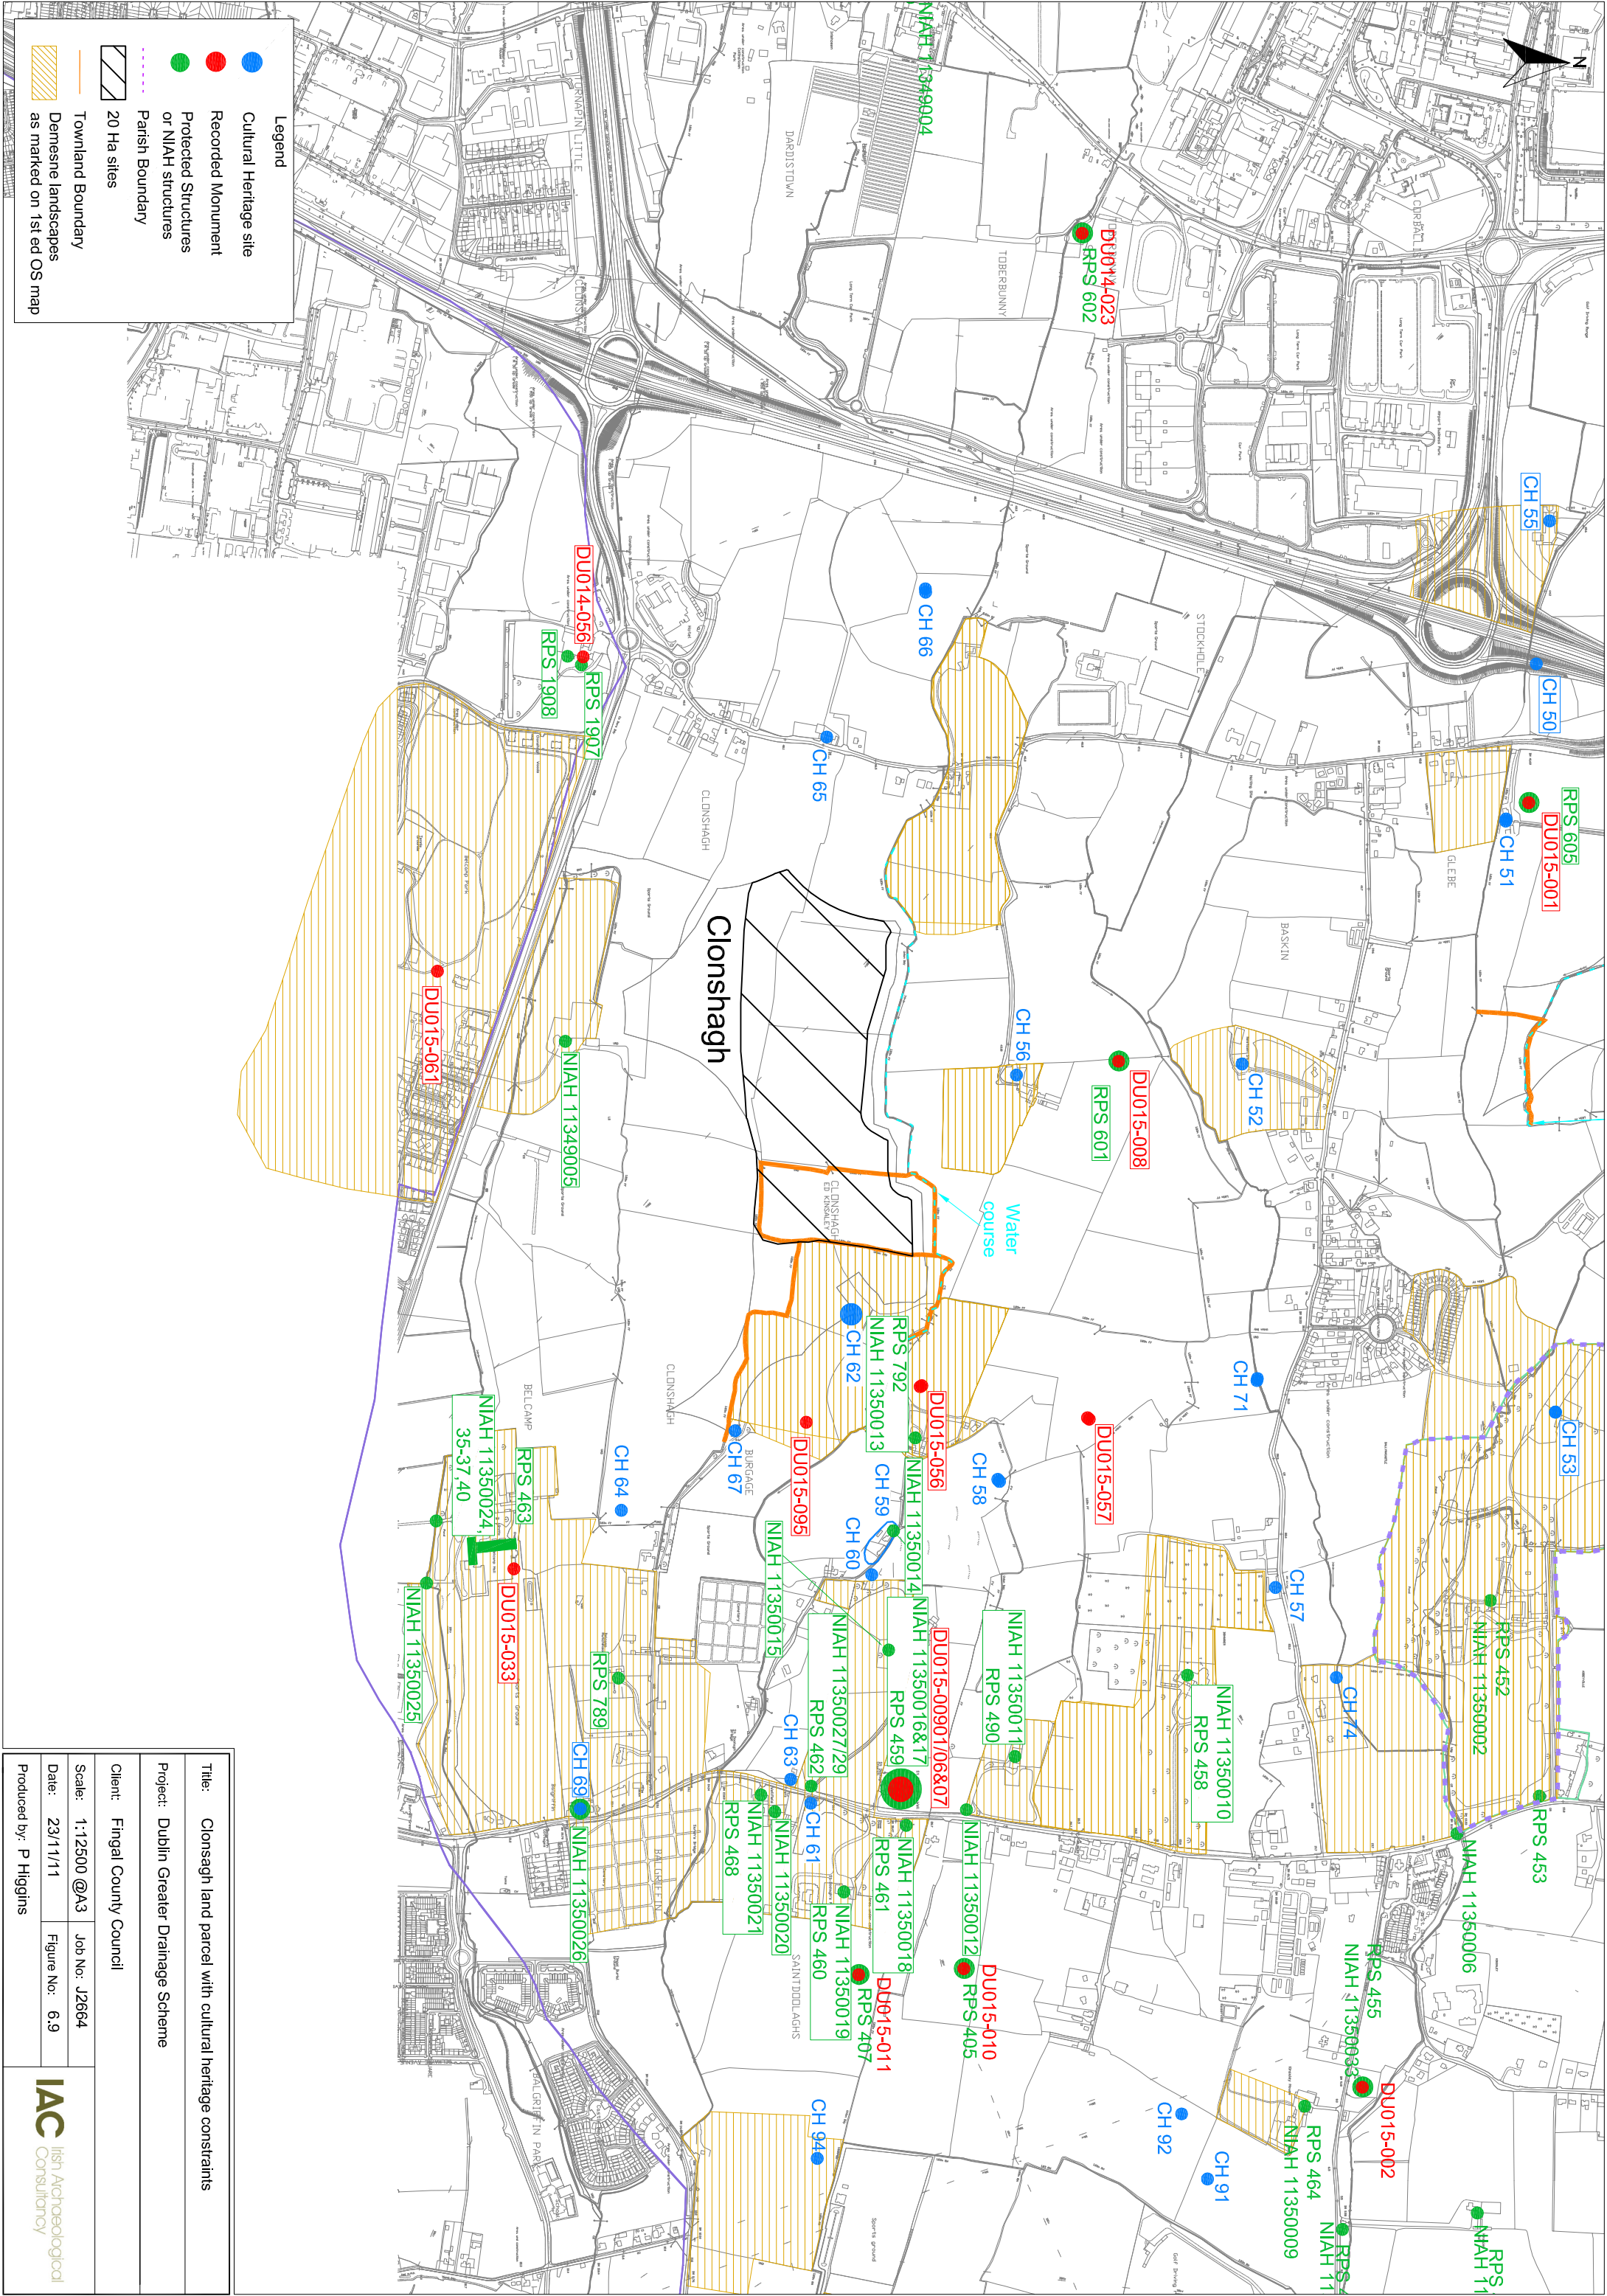
Title: Clonsagh land parcel with cultural heritage constraints		
Project: Dublin Greater Drainage Scheme		
Client: Fingal County Council		
Scale: 1:12500 @A3	Job No: J2664	
Date: 23/11/11	Figure No: 6.9	
Produced by: P Higgins

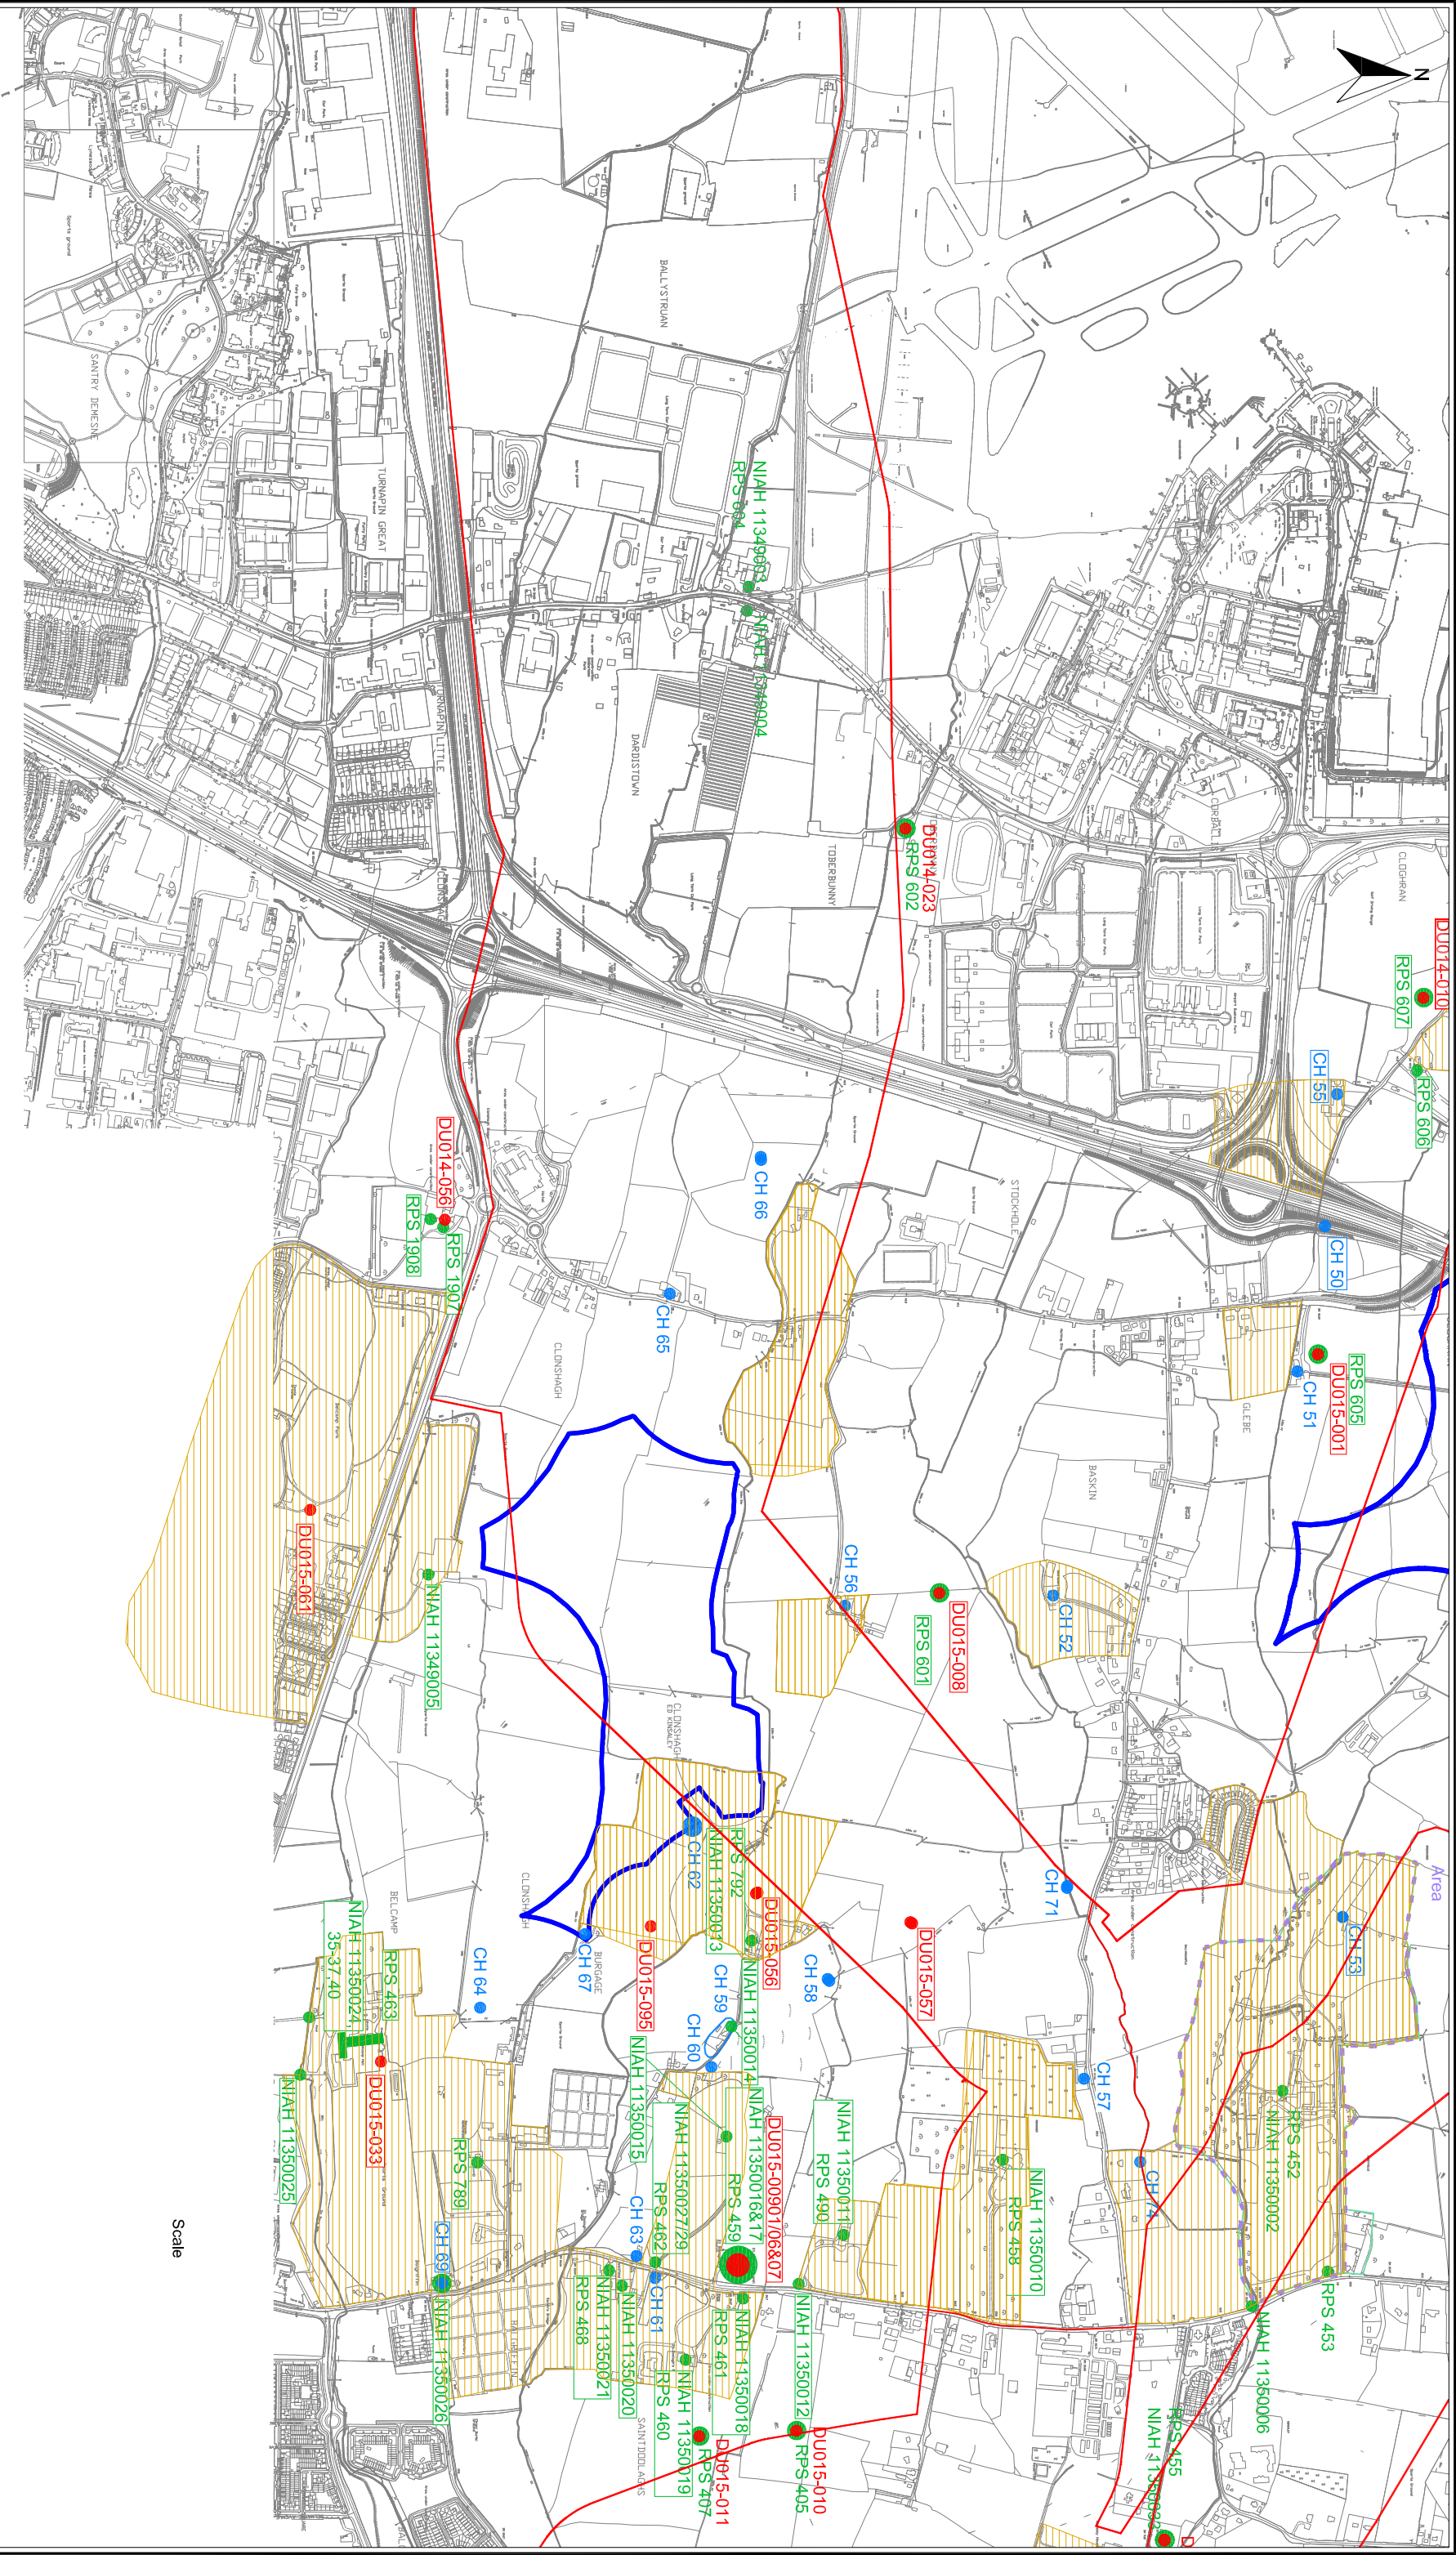
Title: Pipeline B with cultural heritage constraints	
Project: Greater Dublin Drainage Scheme	
Client: Fingal County Council	
Scale: 1:15,000 @A3	Job No: J2664
Date: 30/11/11	Figure No: 6.11b
Produced by: G Kearney

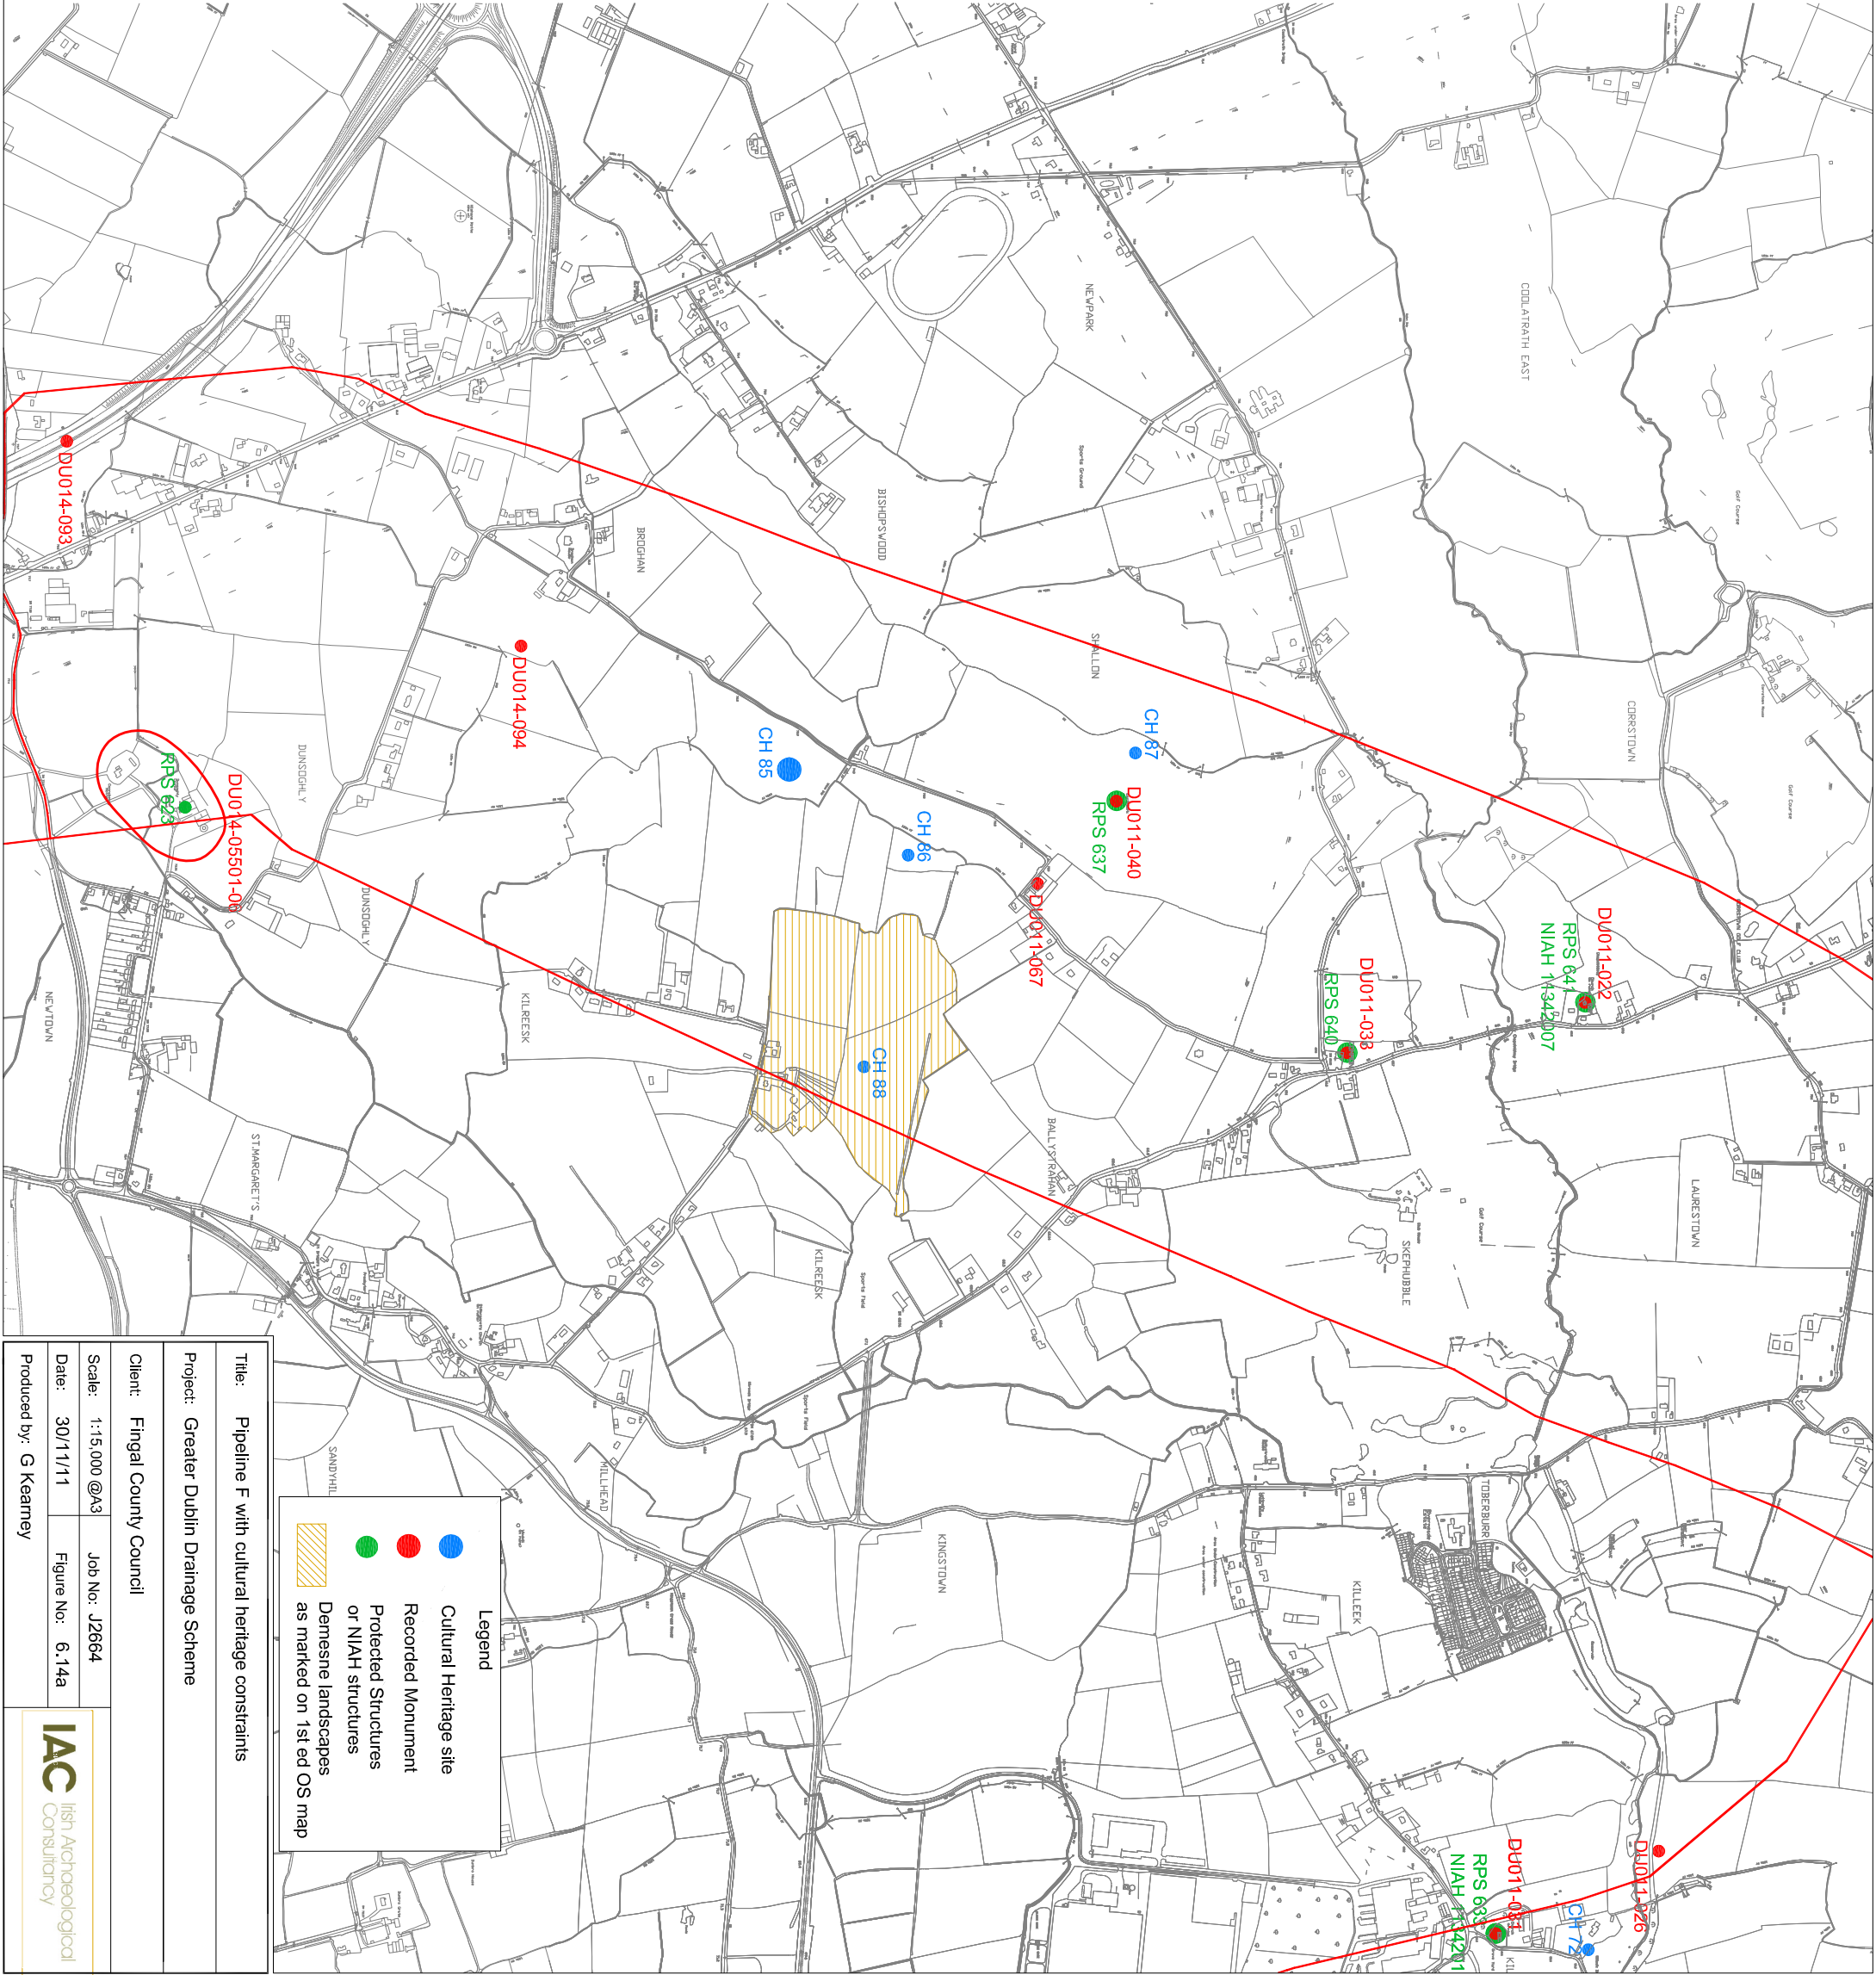
Title: Pipeline F with cultural heritage constraints	
Project: Greater Dublin Drainage Scheme	
Client: Fingal County Council	
Scale: 1:15,000 @A3	Job No: J2664
Date: 30/11/11	Figure No: 6.14a
Produced by: G Kearney
