Greater Dublin Drainage

Alternative Sites Assessment - Phase Two Sites Assessment and Route Selection Report

Cultural Heritage

May 2012

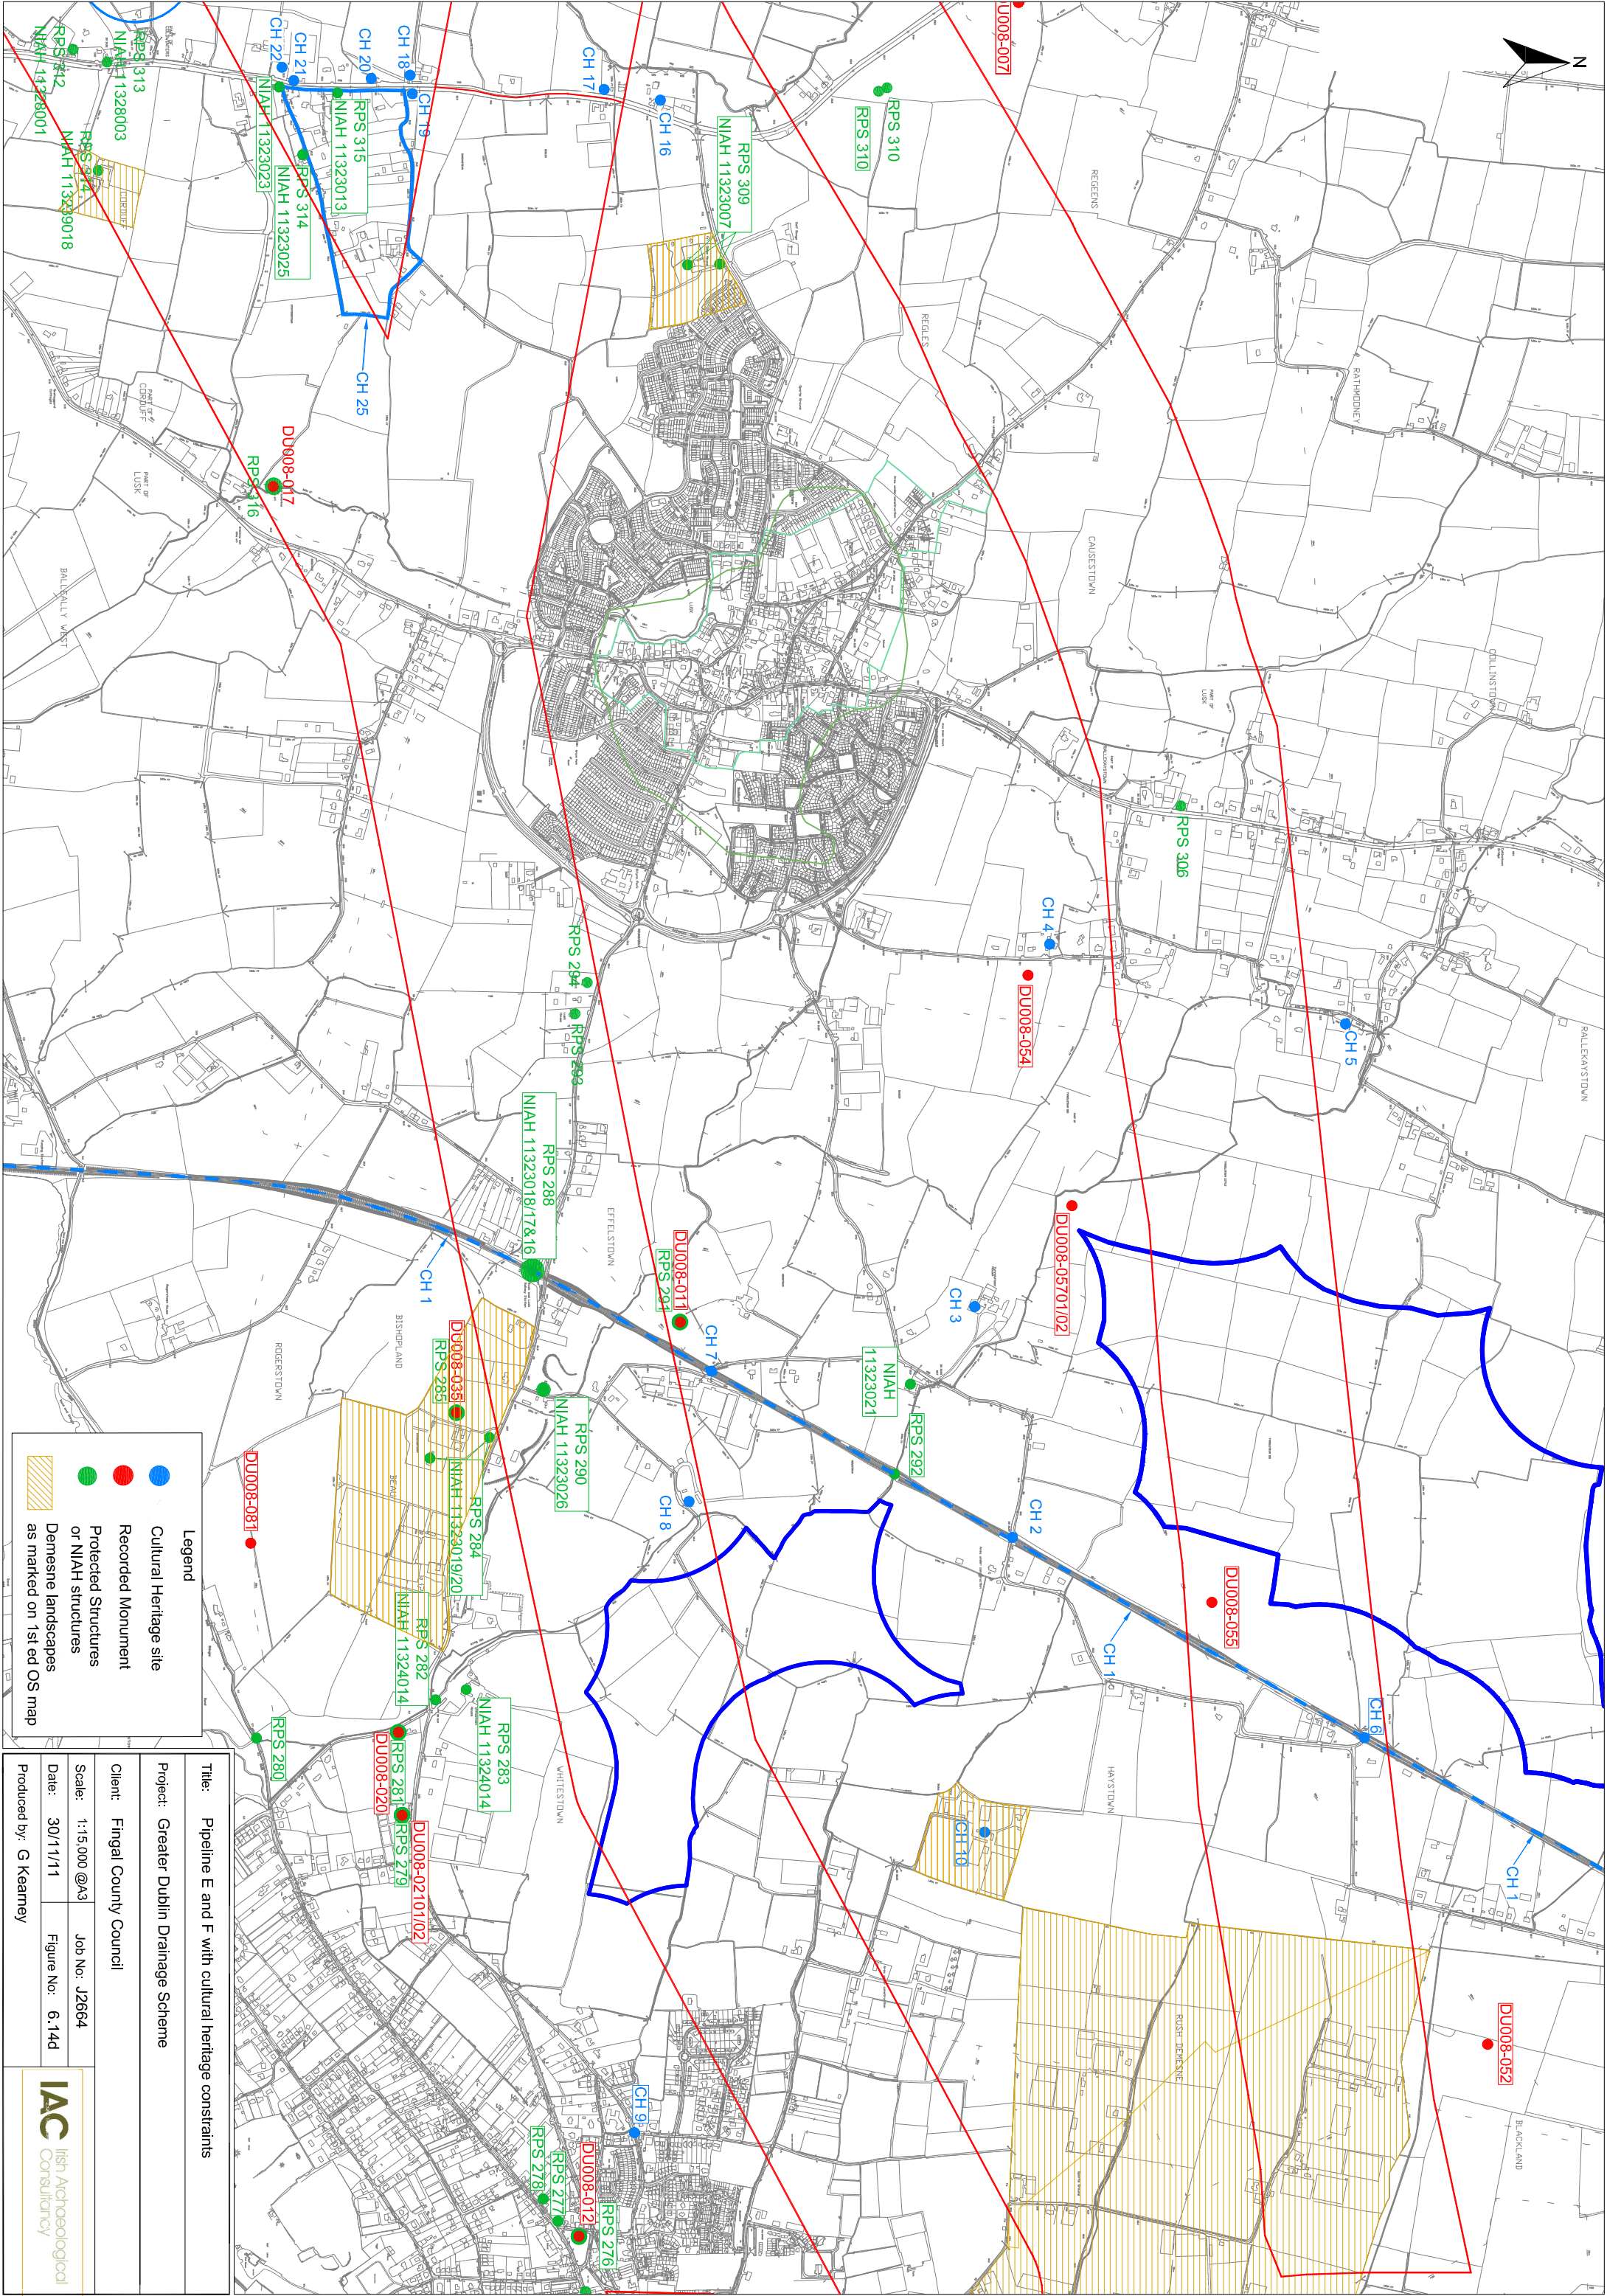
Title: Pipeline E and F with cultural heritage constraints		
Project: Greater Dublin Drainage Scheme		
Client: Fingal County Council		
Scale: 1:15,000 @A3	Job No: J2664	
Date: 30/11/11	Figure No: 6.14d	
Produced by: G Kearney		
<div>
